# BUILDING DIAGNOSTICS INSPECTION

**SUBJECT:** Heat loss survey of National Headquarters

# Heat Loss Evaluation: National Headquarters

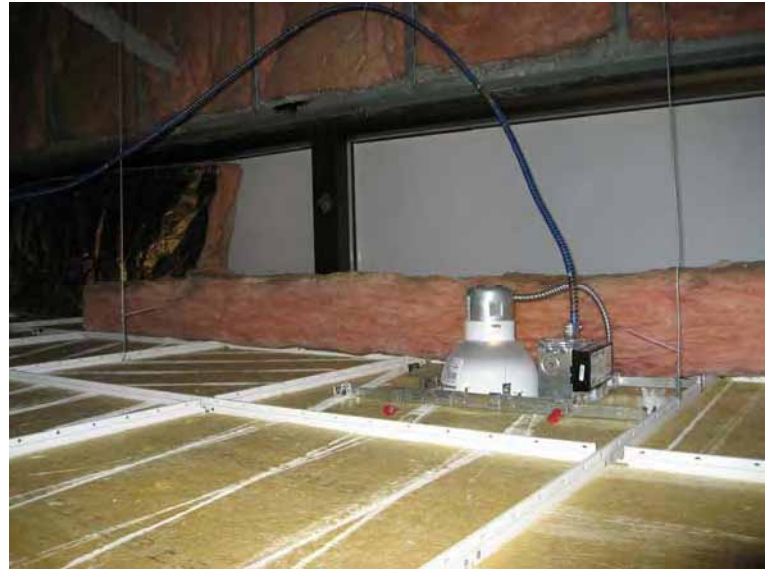
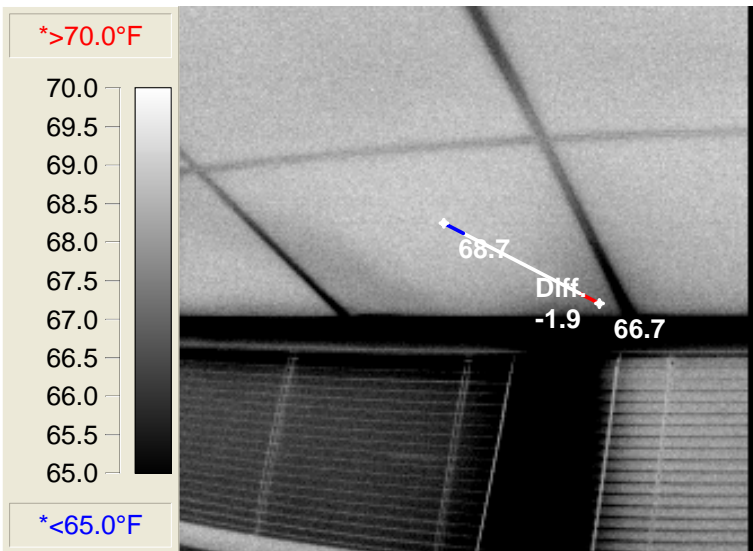
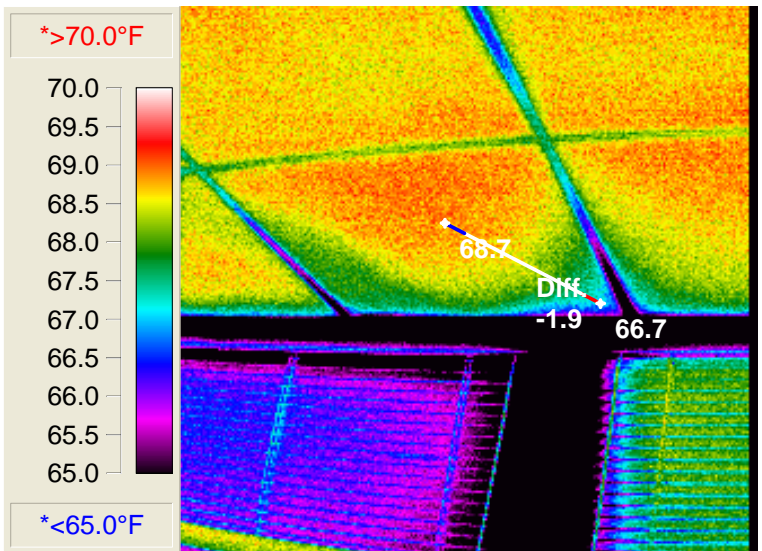
<b>CLIENT</b>		<b>BUILDING</b>	NA	<b>PROBLEM #</b>	1
<b>FLOOR</b>	9	<b>ROOM</b>	9031 Conference room	<b>WALL ORIENTATION</b>	West
<b>LOCATION ALONG WALL</b>		<b>ADDITIONAL LOCATION</b>	Glass panels above ceiling.

**PROBLEM DESCRIPTION** Large areas of batt insulation have fallen away from glass panels. Others are poorly adhered, permitting convective air flows to short circuit the insulation, rendering it ineffective.

This insulation provides no means of securement or proper fit.

This problem is present throughout all areas added to the original building.

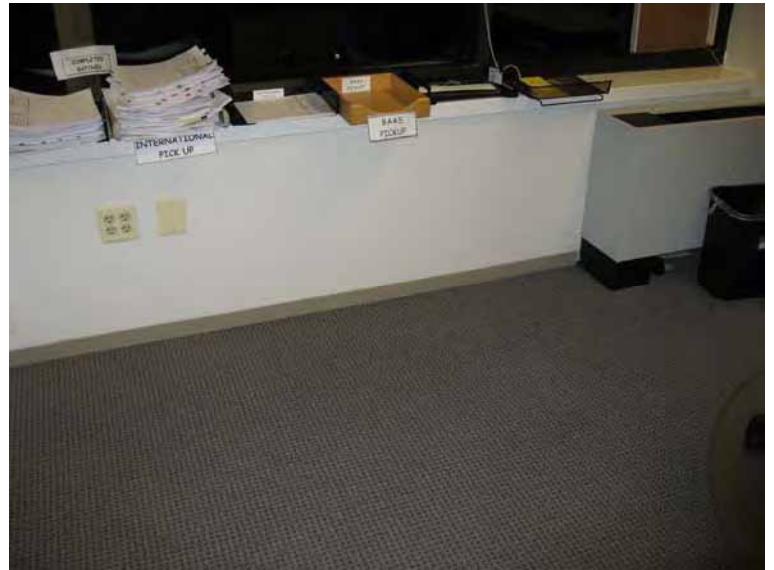
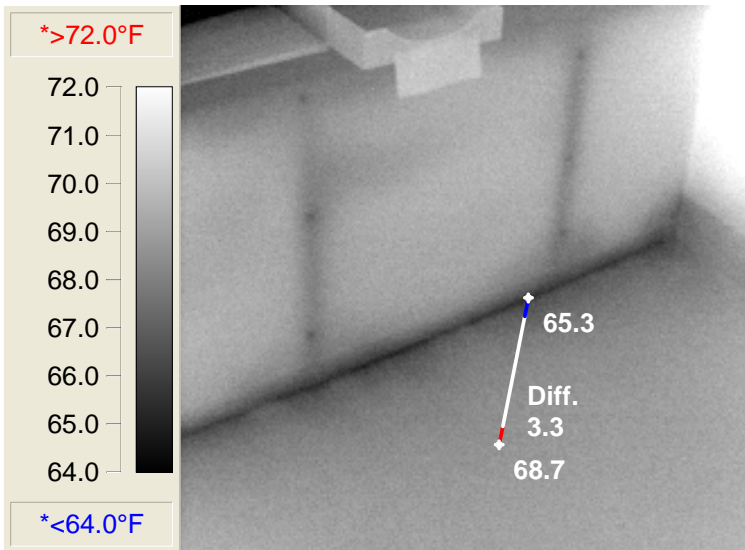
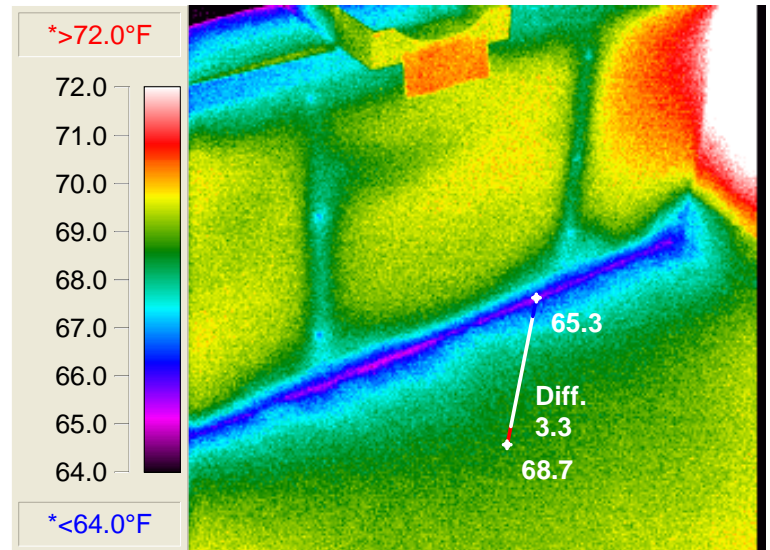
<b>CLIENT</b>		<b>BUILDING</b>		<b>PROBLEM #</b>	7
<b>FLOOR</b>	9	<b>ROOM</b>	9024	<b>WALL ORIENTATION</b>	North
<b>LOCATION ALONG WALL</b>		<b>ADDITIONAL LOCATION</b>

**PROBLEM DESCRIPTION** Minor infiltration is present at floor. This type of pattern is widespread along the north wall. Check the balcony below.

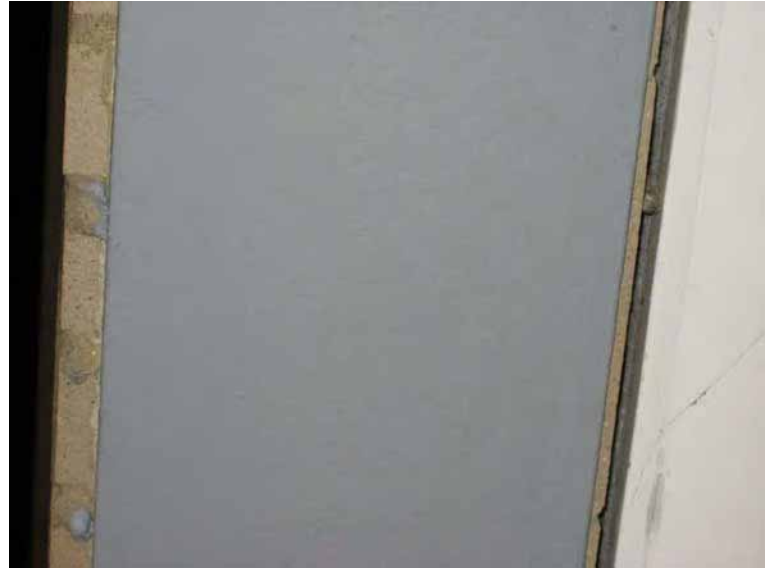
<b>CLIENT</b>		<b>BUILDING</b>		<b>PROBLEM #</b>	8
<b>FLOOR</b>	8	<b>ROOM</b>	8024	<b>WALL ORIENTATION</b>	North
<b>LOCATION ALONG WALL</b>	Center		<b>ADDITIONAL LOCATION</b>

**PROBLEM DESCRIPTION** Balcony ceiling below problem # 7.

A 1" gap is present between the drywall ceiling and the masonry wall. This gap is open to the interior. Air infiltration through this gap is the likely source of infiltration seen above and in several of the following the following examples.

This gap is present around the entire floor and provides substantial total area for infiltration.

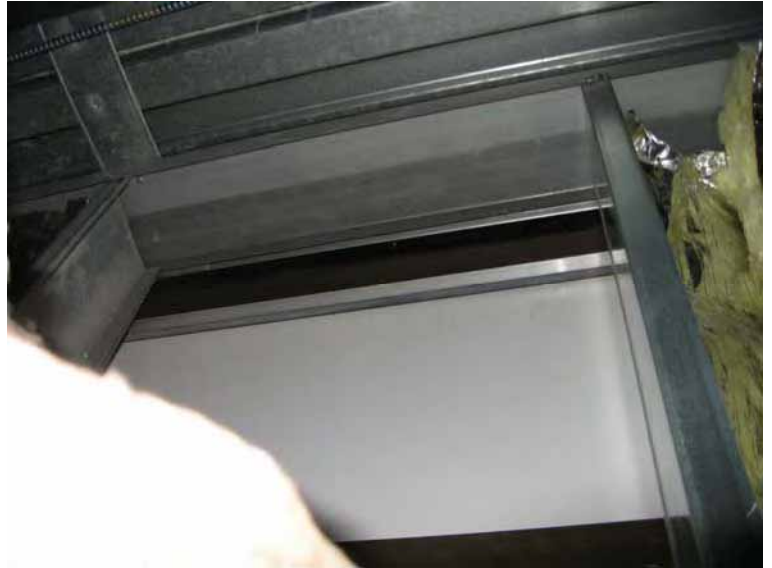
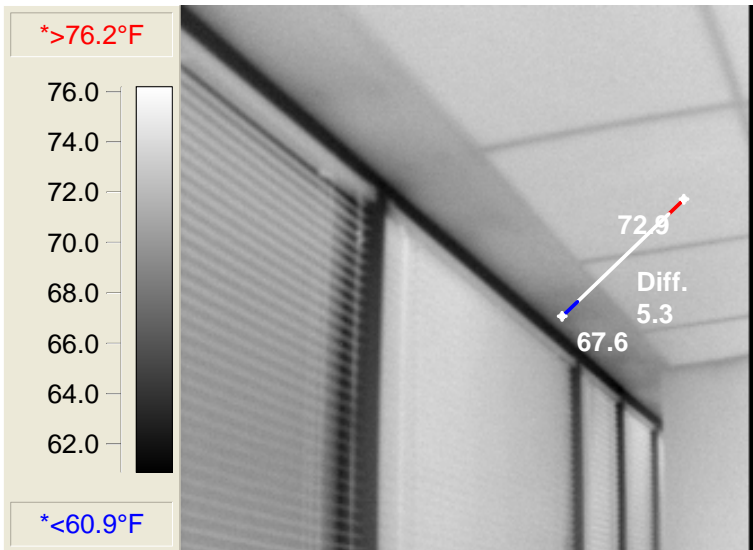
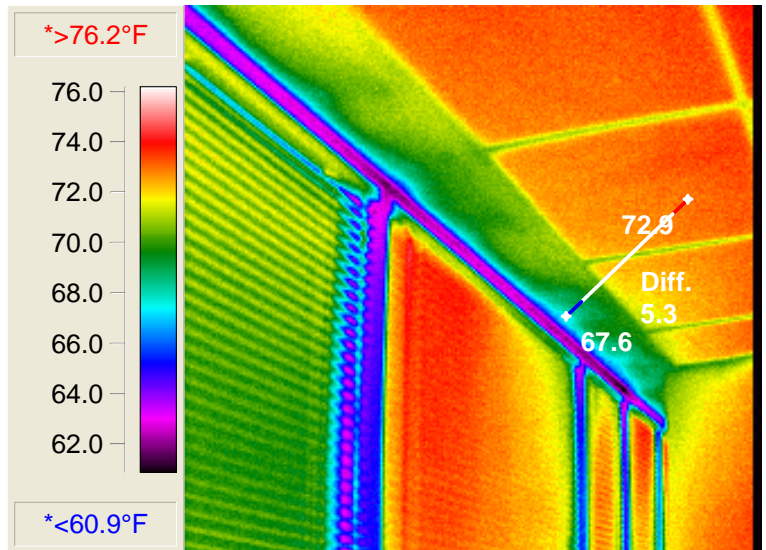
<b>CLIENT</b>		<b>BUILDING</b>		<b>PROBLEM #</b>	9
<b>FLOOR</b>	8	<b>ROOM</b>	8007, hall	<b>WALL ORIENTATION</b>	North
<b>LOCATION ALONG WALL</b>		<b>ADDITIONAL LOCATION</b>	Above ceiling

Photograph shows glass panel above ceiling. Air infiltration occurs over the top of the glass panel frame. It is not properly sealed from the balcony ceiling. This problem is probably present around the entire floor. Air infiltration can be readily felt at this area.

This defect is a significant source of energy loss in this building. The problem was particularly severe in the "nose" area.

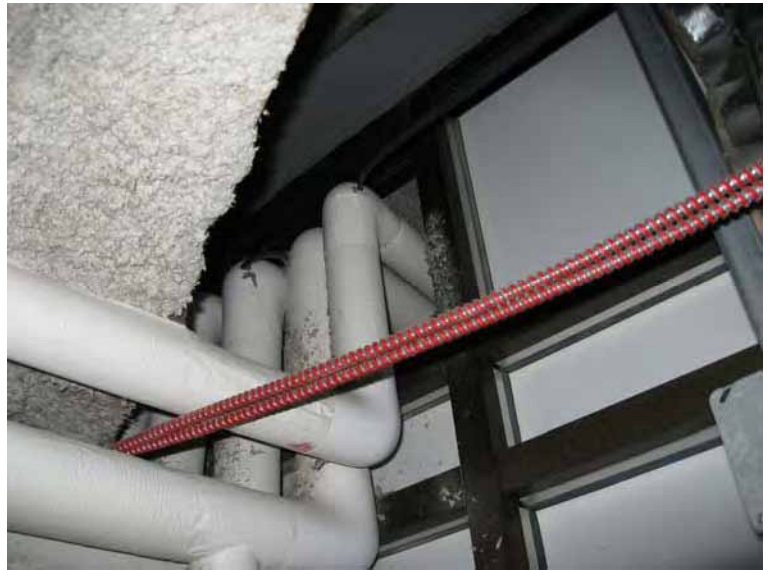
<b>CLIENT</b>		<b>BUILDING</b>		<b>PROBLEM #</b>	10
<b>FLOOR</b>	8	<b>ROOM</b>	8017	<b>WALL ORIENTATION</b>	West
<b>LOCATION ALONG WALL</b>				<b>ADDITIONAL LOCATION</b>

**PROBLEM DESCRIPTION** Pipe chase is open into balcony ceiling plenum, permitting substantial infiltration. Most pipe penetrations that we saw were sealed. However, a thorough inspection should be made for any we missed, especially along the south wall.

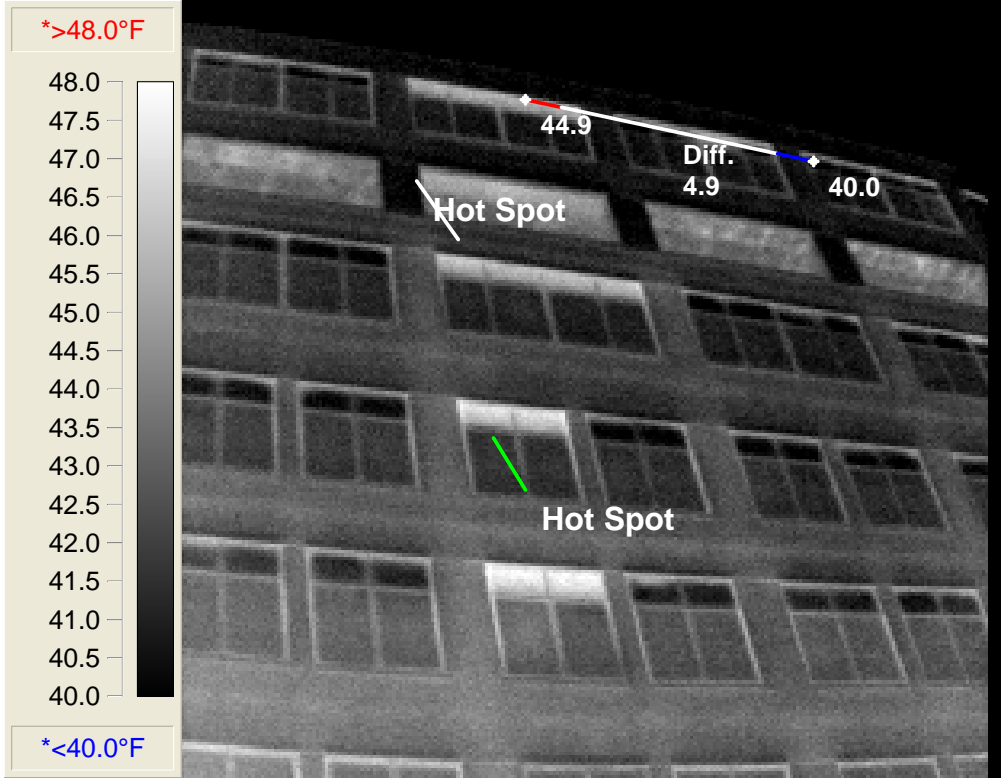
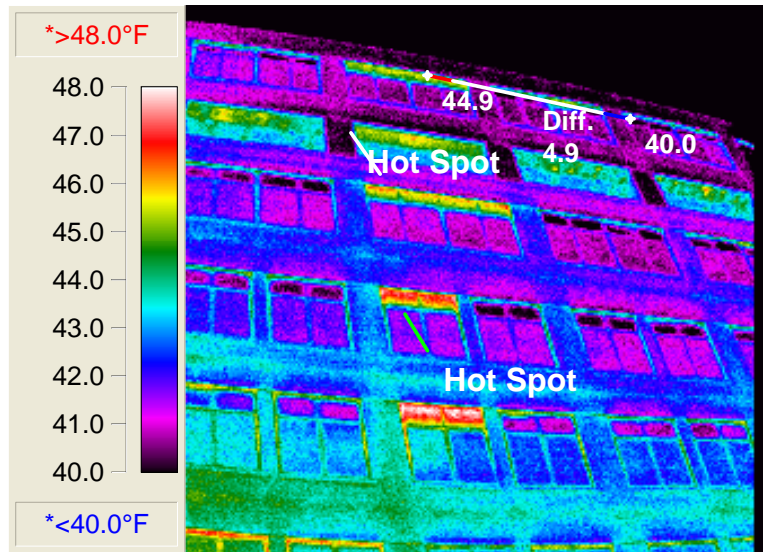
<b>CLIENT</b>				<b>BUILDING</b>			<b>PROBLEM #</b>	14
<b>FLOOR</b>	NA	<b>ROOM</b>	J Street	<b>WALL ORIENTATION</b>		South		
<b>LOCATION ALONG WALL</b>			East end	<b>ADDITIONAL LOCATION</b>

Hot spots are present on glass panels above windows. The insulation here is improperly installed.
