PREDICTIVE MAINTENANCE INSPECTION

CLIENT: Major Widgets

DATE: October 5, 2000

SUBJECT: Infrared, vibration and ultrasonic survey of electrical and mechanical equipment

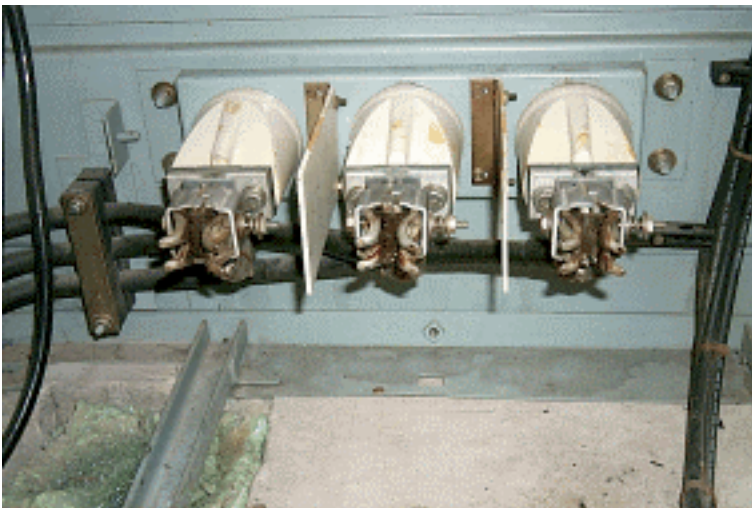
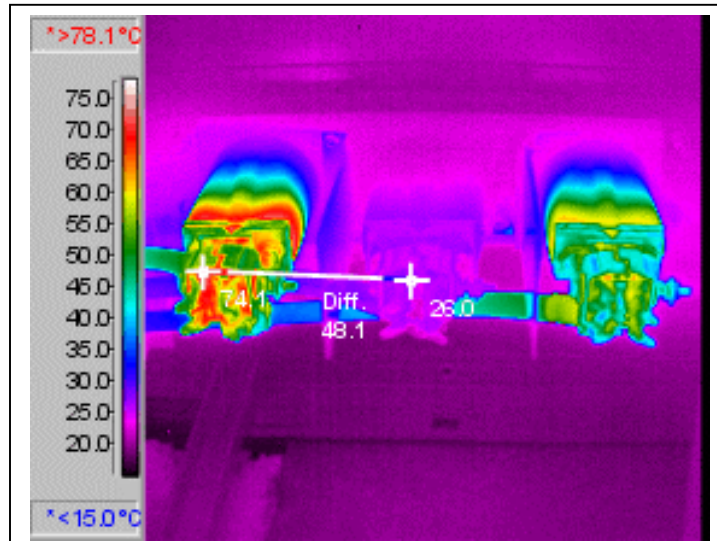
CLIENT	Major Widgets
PROBLEM NUMBER	1
EQUIPMENT	River, Pump 3 starter

PROBLEM DESCRIPTION T1 and T3 secondary stabs show excessive heat. Micro-ohmmeter readings were taken that shows high resistance (20 milliohms vs 53 microhms) across the stab clips. After moving the clips, the resistance was eliminated.

RECOMMENDATION Problem corrected. No further action required.

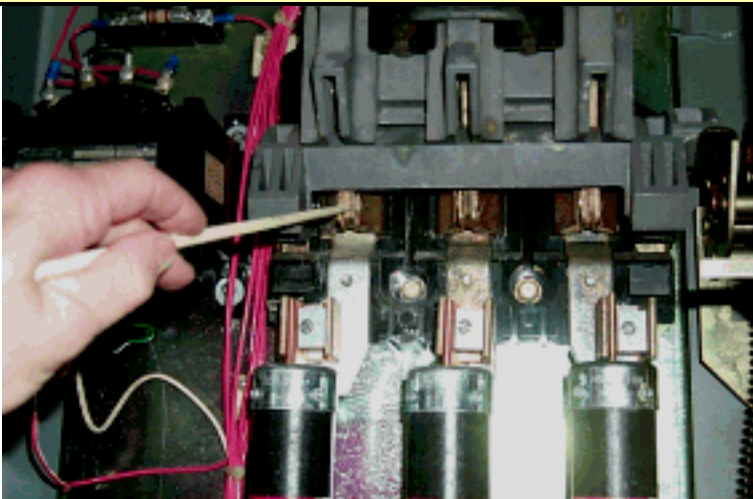
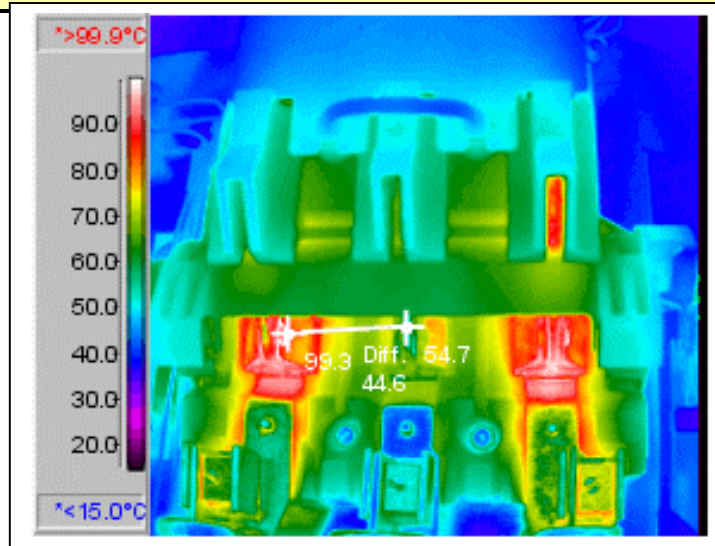
CLIENT	Major Widgets
PROBLEM NUMBER	2
EQUIPMENT	Liquid Pack, North Demister Fan starter

PROBLEM DESCRIPTION Disconnect switch, A and C phases, show excessive heat. FOP test shows poor contact at switch pivot points.

RECOMMENDATION Problem repaired. No further action required.

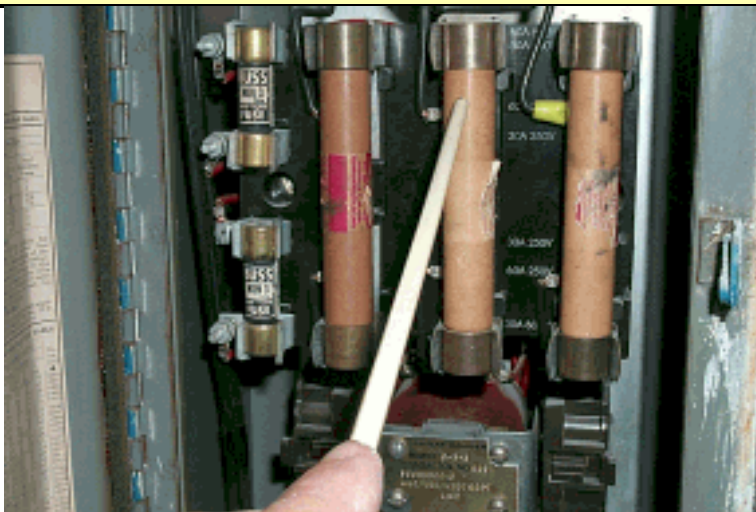
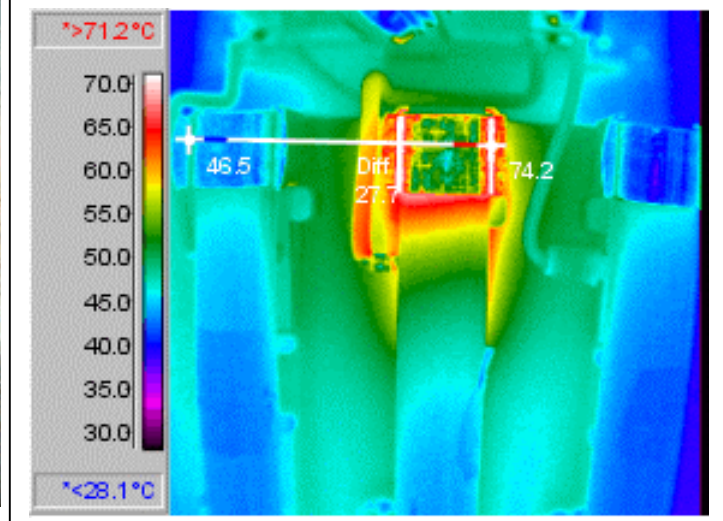
CLIENT	Major Widgets
PROBLEM NUMBER	3
EQUIPMENT	Bars, 5th floor, DEFI, west wall, starter Exhaust fan #2

PROBLEM DESCRIPTION B phase fuse, line side, shows excessive heat. FOP test shows poor contact inside renewable link fuse.

RECOMMENDATION Replace all renewable link fuses with non-renewable fuses.

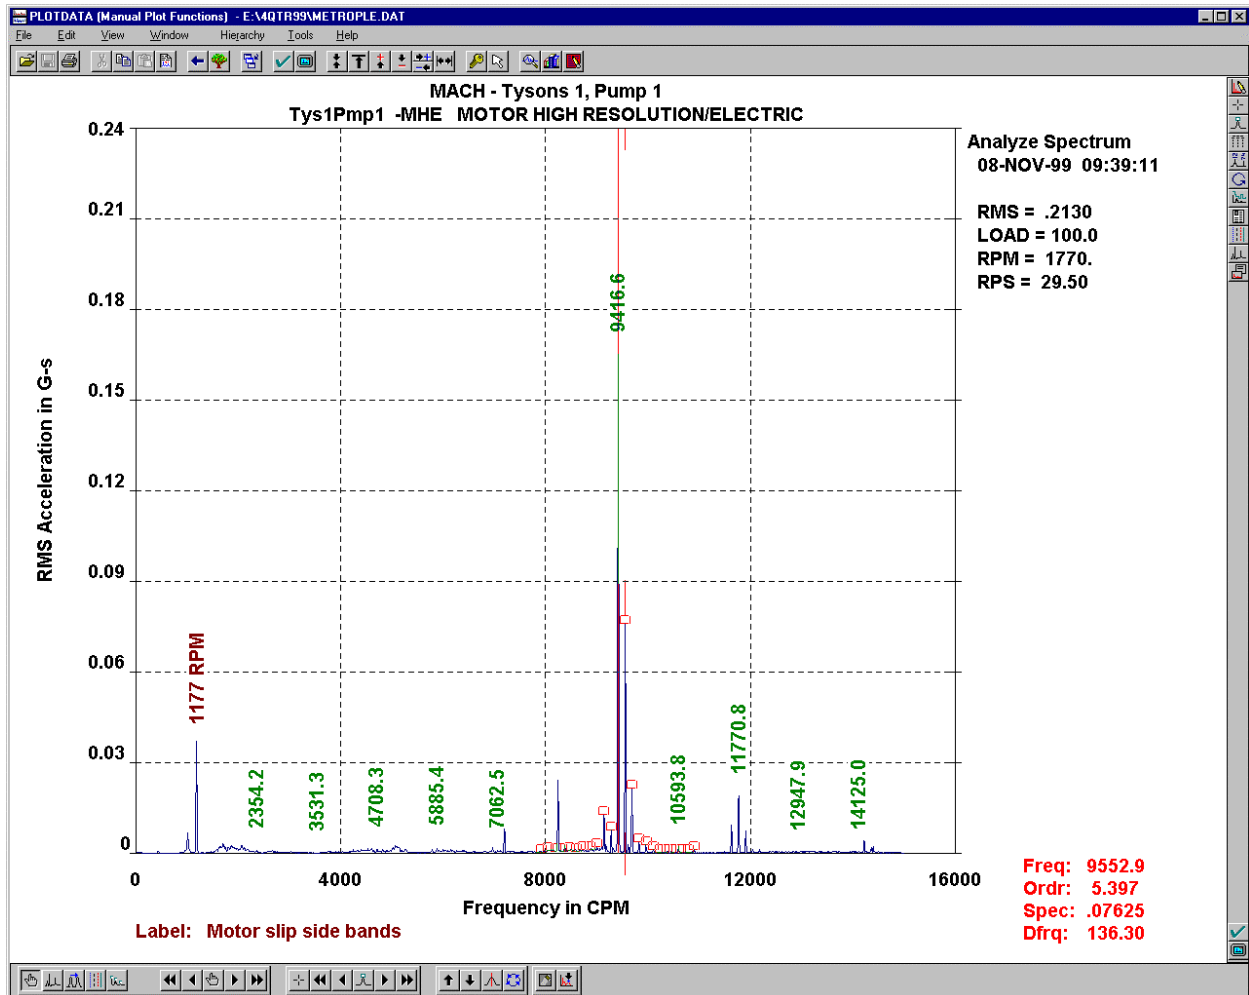
MACHINE: Tysons 1 station, Pump 1

PROBLEM DISCUSSION: This motor has an audible beat. Vibration testing shows sidebands around several shaft speed harmonics. The side bands are spaced at slip frequency x the number of motor poles. This generally indicates a rotor fault such as broken end ring or rotor bars.

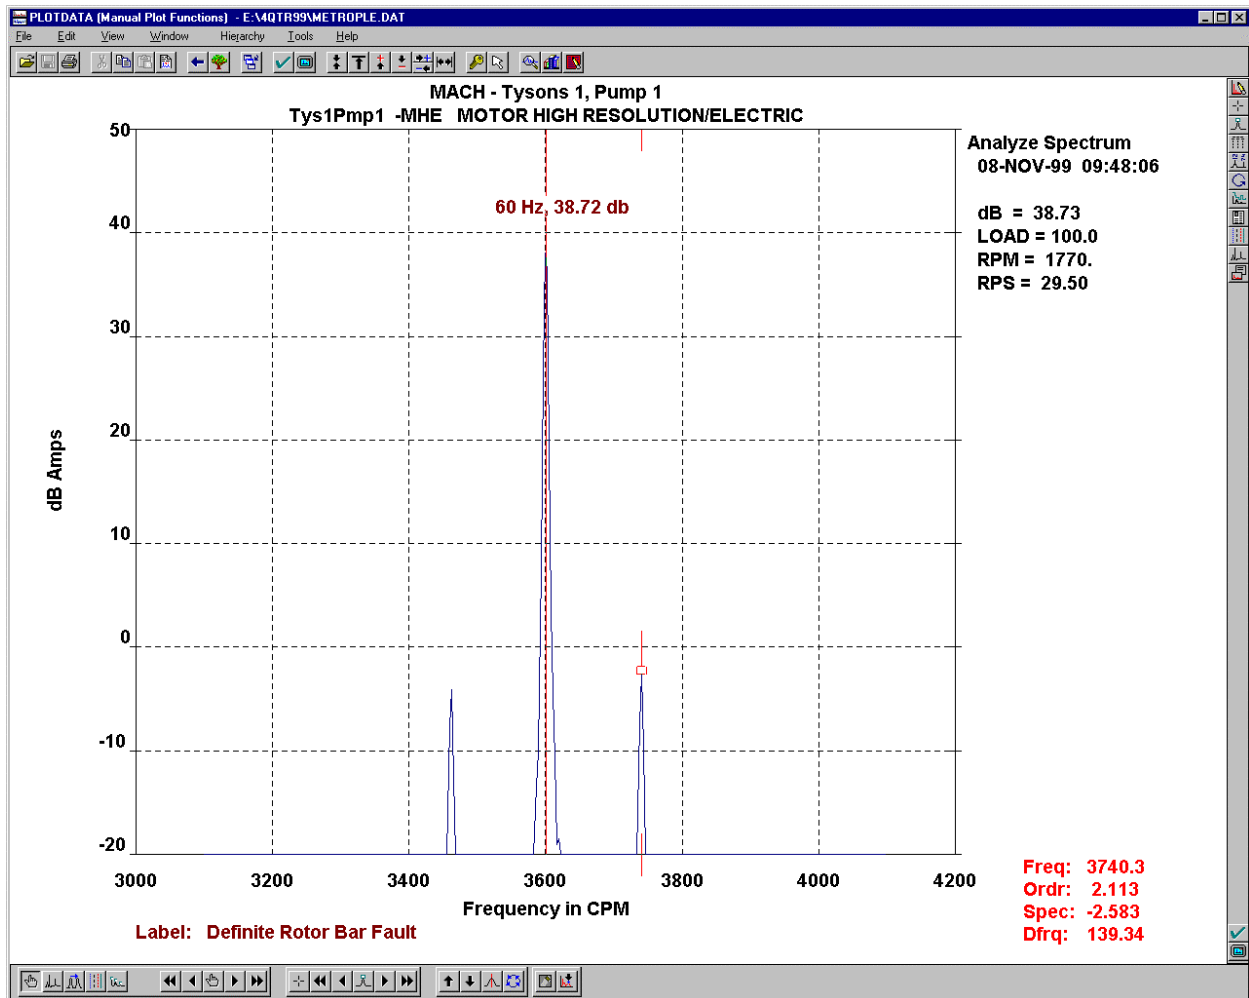
MACHINE: Tysons 1 Station, Pump 1

PROBLEM DISCUSSION: Current signature shows motor slip X number of poles side bands at 41.3 db below 60 Hz current level. If the difference is less than 46 db, then a rotor bar problem is present.

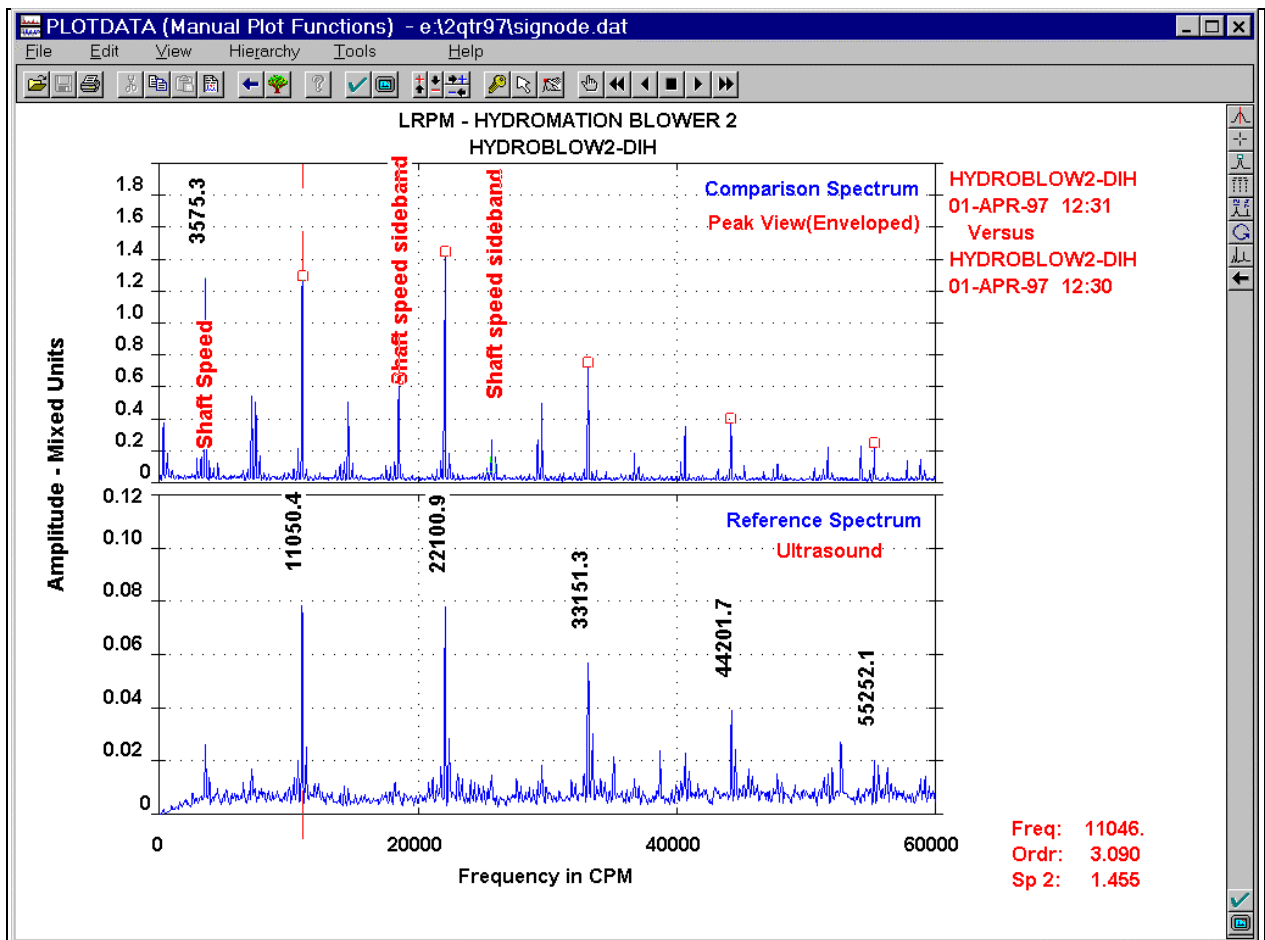
MACHINE: Hydromation blower #2 (Magnus Line)

PROBLEM DISCUSSION: Vibration spectra for the inboard (coupling side) fan bearing, shows dramatic increase in high frequency vibration. Very high ultrasound is present. The demodulated ultrasound spectrum shows likely bearing fault frequencies. The peak view spectrum shows similar fault frequencies and shaft speed sidebands around each fault frequency peak. These data suggest a severe bearing fault and looseness on the shaft.
