Predictive Testing Report

CLIENT: MAJOR WIDGETS

DATE: May 25, 2009

SUBJECT: Infrared, vibration and ultrasonic survey of electrical and mechanical equipment

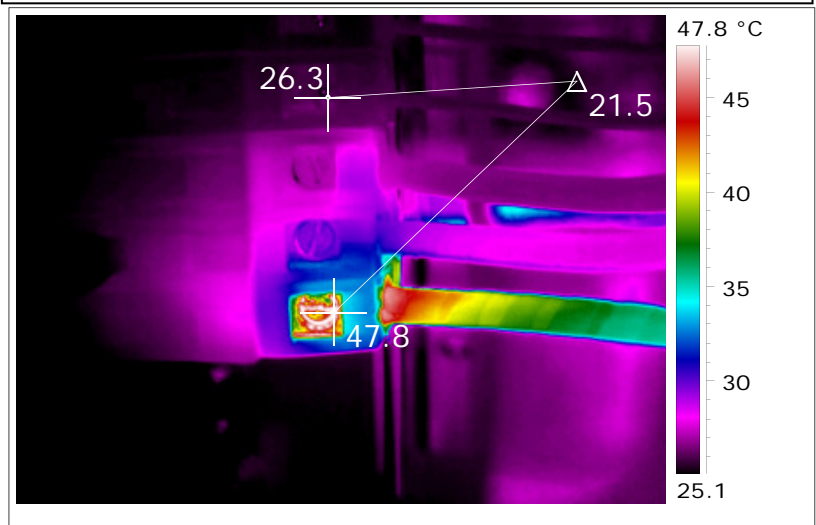
CLIENT	Major Widgets
PROBLEM NUMBER	1
EQUIPMENT	Main electric room, emergency lighting panel

PROBLEM DESCRIPTION 3 pole breaker 20-24, #24, load side, shows excessive heat. FOP test shows a loose connection.

RECOMMENDATION Problem repaired
No further action required.

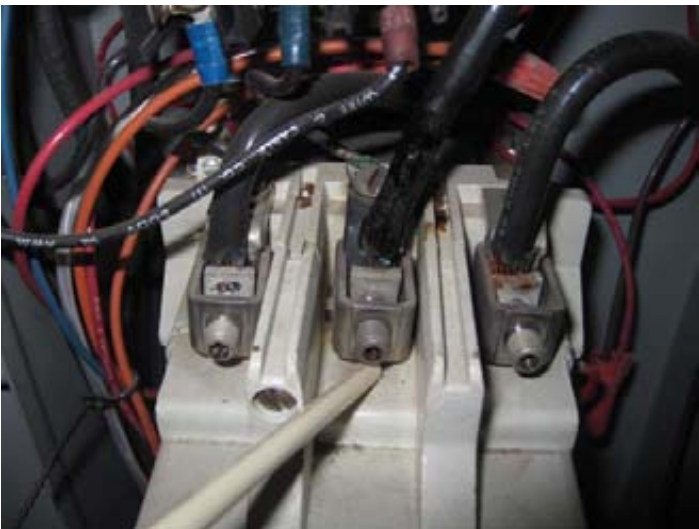
CLIENT	MAJOR WIDGETS
PROBLEM NUMBER	2
EQUIPMENT	Penthouse, pump 2 contactor

PROBLEM DESCRIPTION Contactor, line side, B phase, shows excessive heat. FOP test shows poor internal contact. Feed is damaged from heating.

HIGH PRIORITY: Yes

RECOMMENDATION Open contactor. Check internal connections. Check contact surfaces. Reassemble, using FOP test to ensure proper operation. Repair damaged feeder.
