Aerial Infrared Steam System Survey

CLIENT: Major Widgets

DATE: October 6, 1999

SUBJECT: Aerial infrared steam system survey of undergrounds
team and condensate lines.

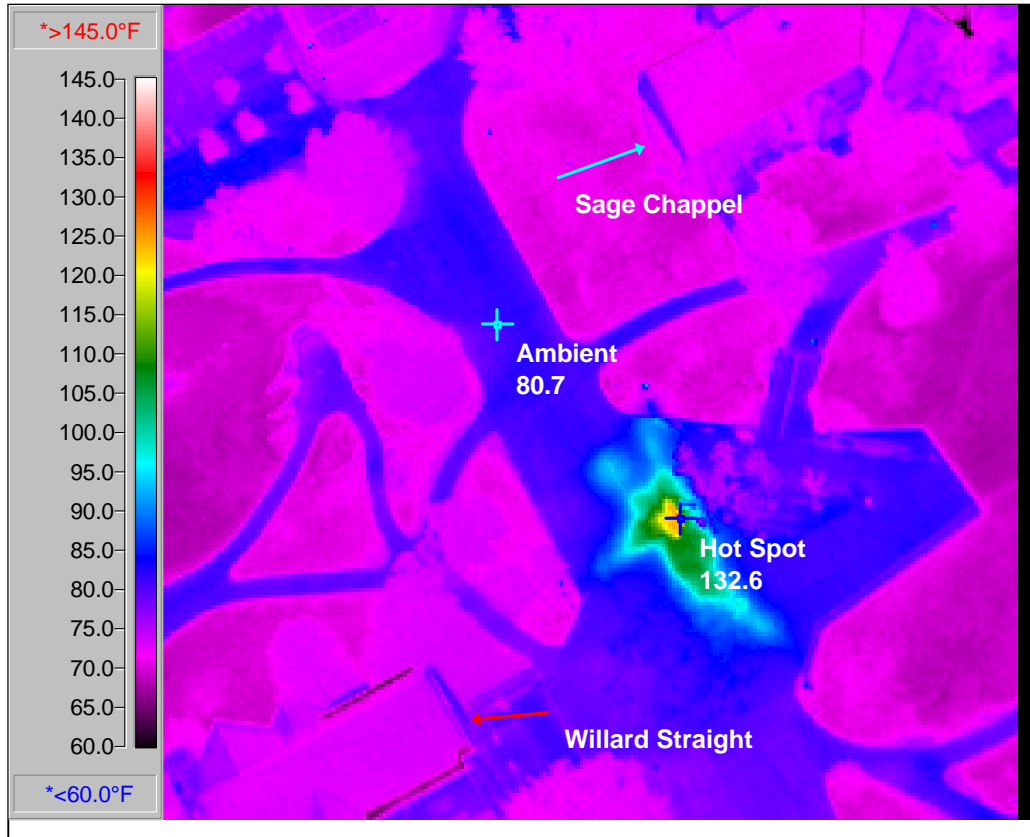
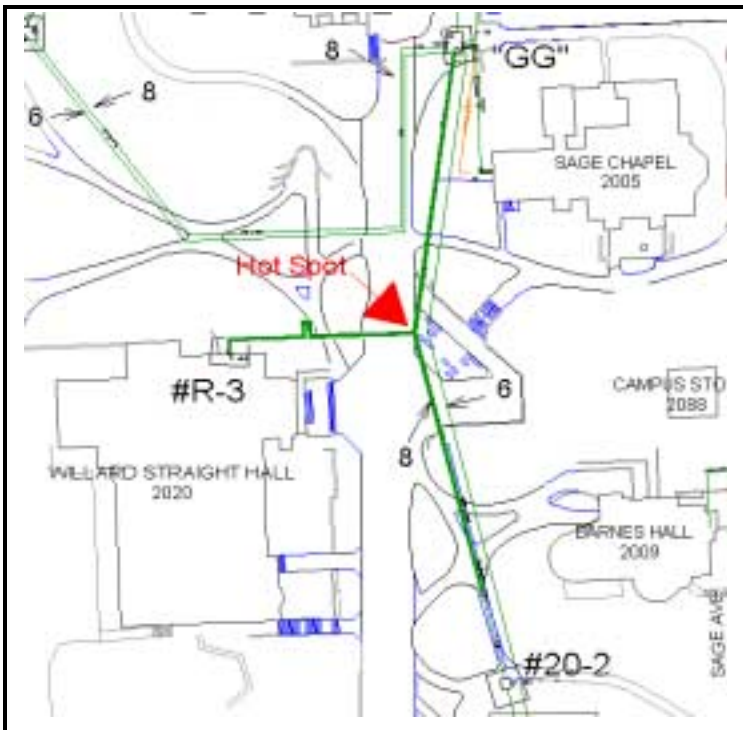
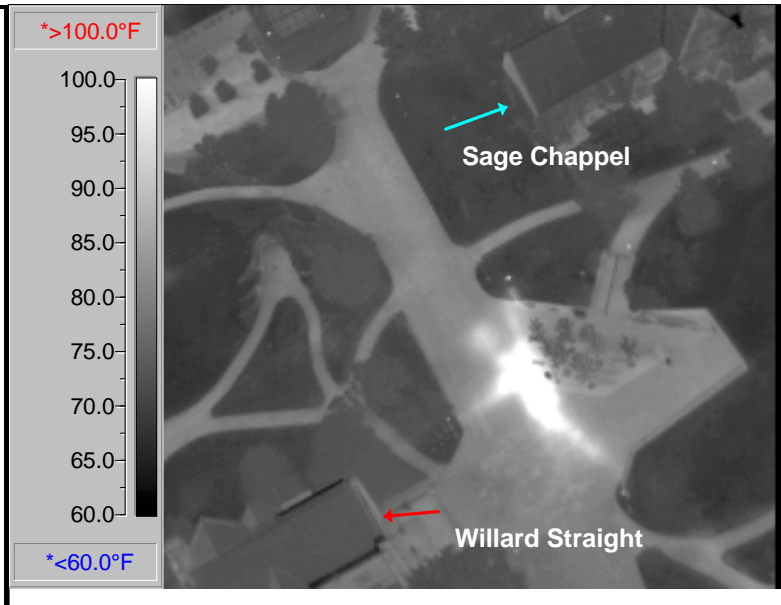
Problem #:1

Location: Intersection of line to Willard Straight and 8" main line

Problem Analysis: Since this hot spot occurs at what appears to be the intersection of the service to Willard Straight, a pipe coupling may have failed, producing a very high ground surface temperature and significant heat bloom. When viewed on the ground, the point of highest heat achieves a temperature of 153oF.

Time: 11:07:30

Note: Subsequent excavation revealed a leak at the hot spot.

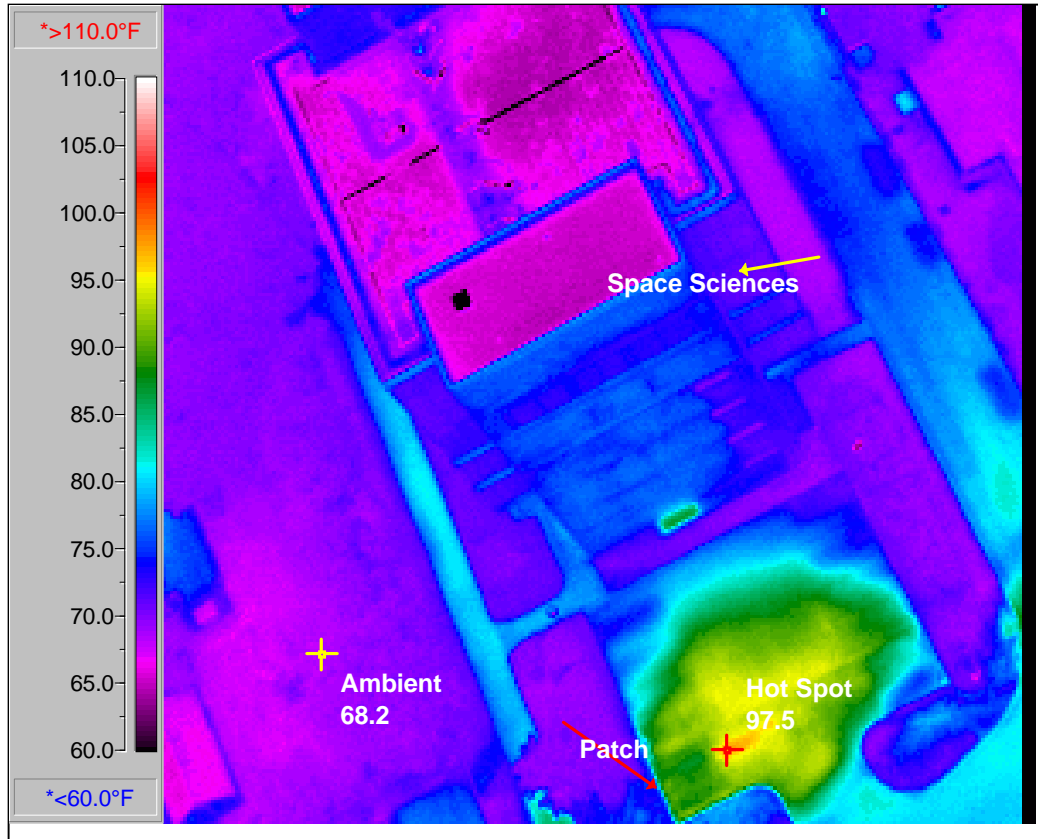
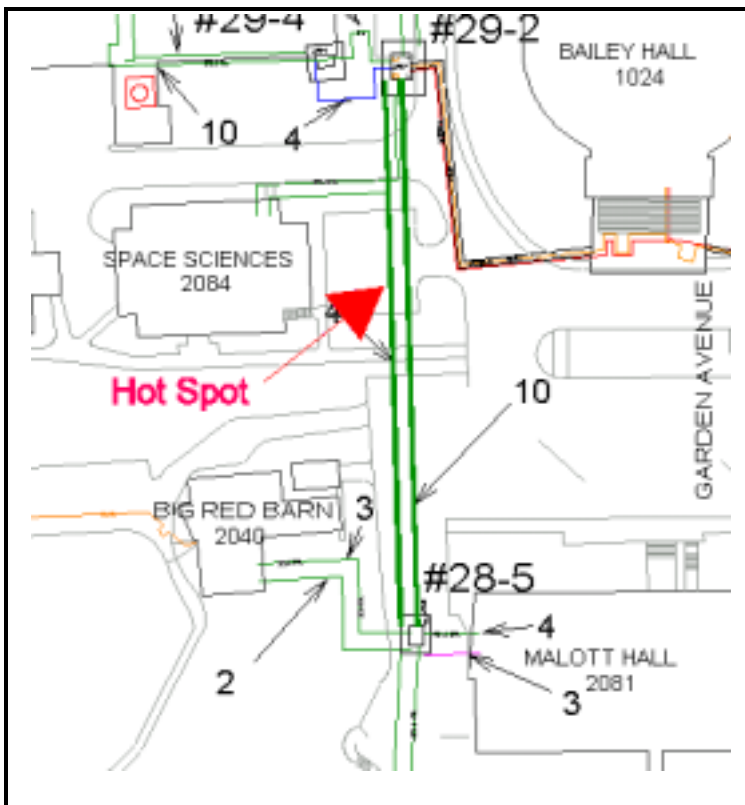
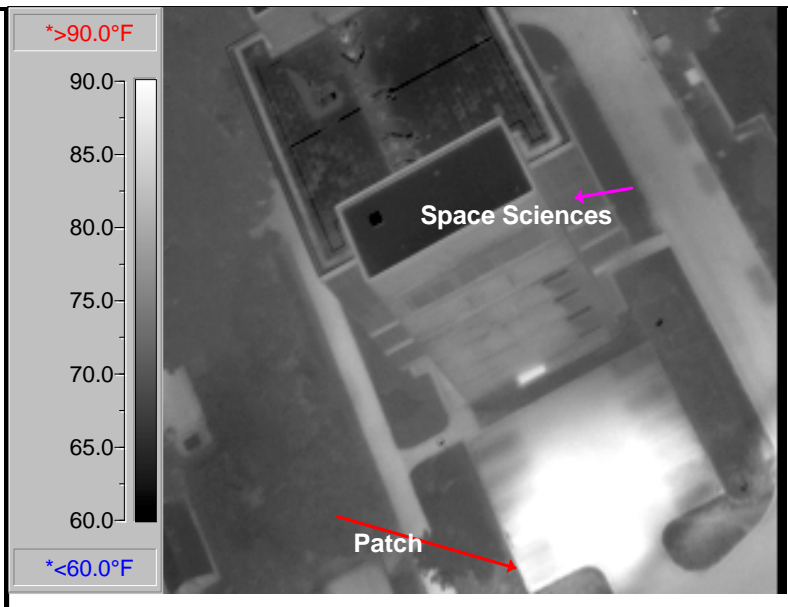
Problem #2

Location: Parking lot on east side of Space Sciences

Problem Analysis: This is a known leak area. It was previously excavated. The patch from the excavation is several feet from the hottest spot. The hottest spot may contain the leak. However, when the adjacent line area was excavated previously, there was no physical leak evidence. Thus, this hot spot may be where hot water is accumulating after running between the insulation and the pipe.

Time: 11:29:15

NOTE: Subsequent excavation revealed that the leak was, in fact, at the hot spot.

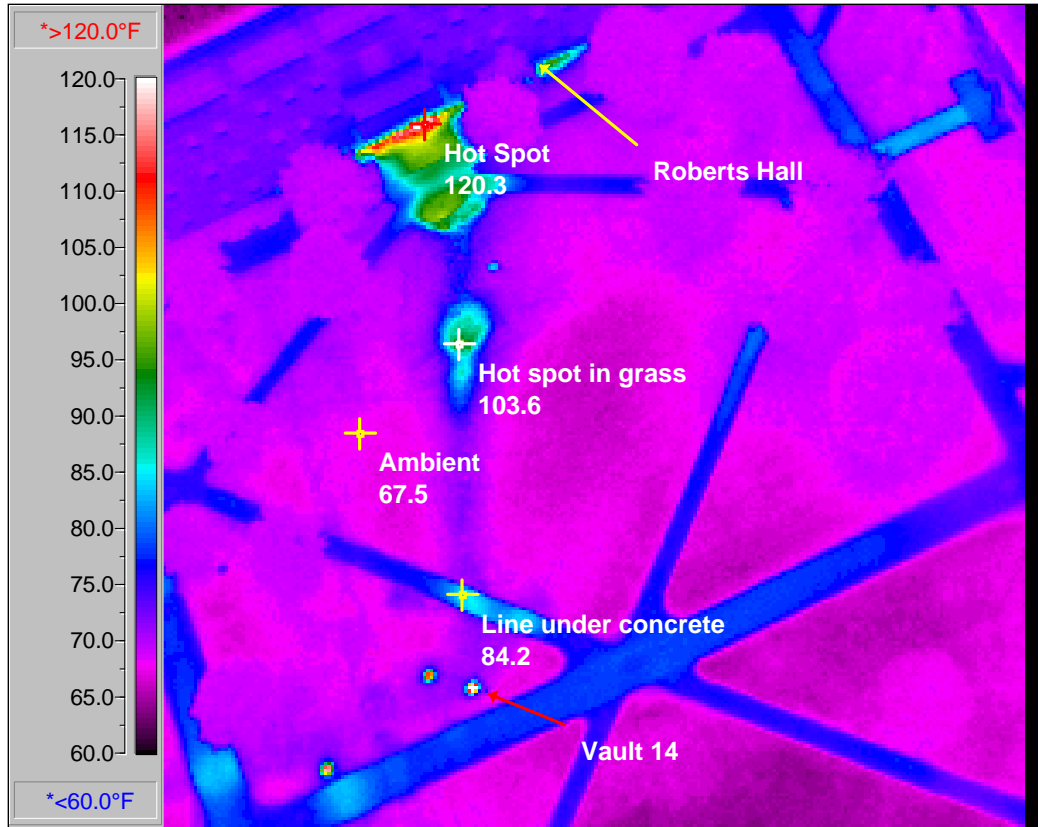
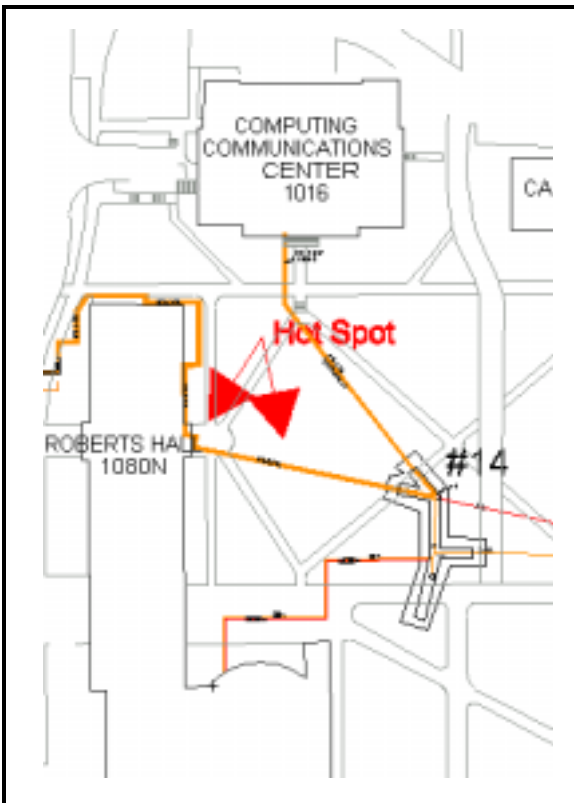
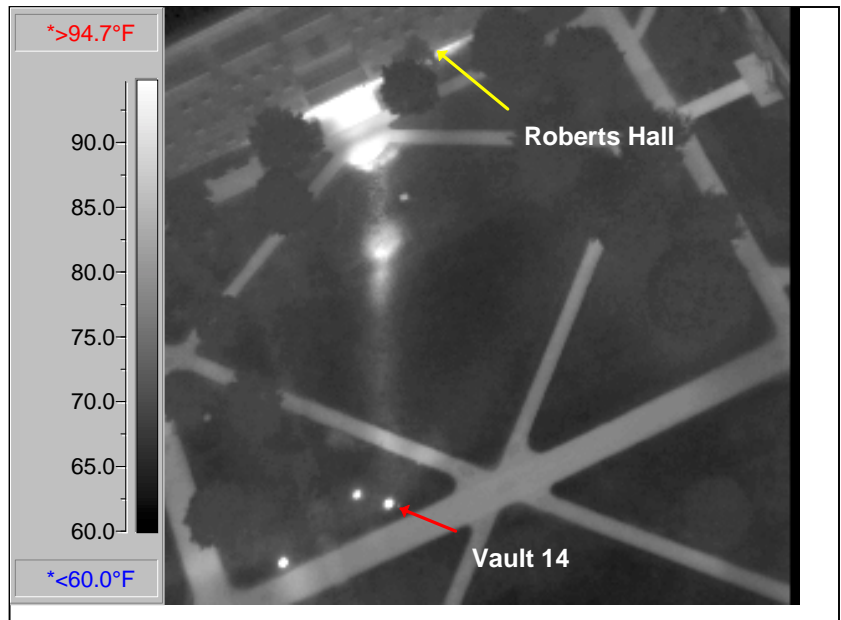
Problem #:4

Location: Main entrance to Roberts Hall and grass area in quad

Problem Analysis:A large area of heating extends along the main entrance. The heat is hottest along the building but extends beyond the concrete sidewalk to the grass. An additional hot spot is located in the grass. This area was found in the 1993 tape at 23:38:37. None of the hot spots in the current images were present in 1993. All are new, likely leaks.

Time: 22:41:56
