Predictive Testing Report

CLIENT: MAJOR WIDGETS

DATE: May 25, 2009

SUBJECT: Infrared, vibration and ultrasonic survey of electrical and mechanical equipment

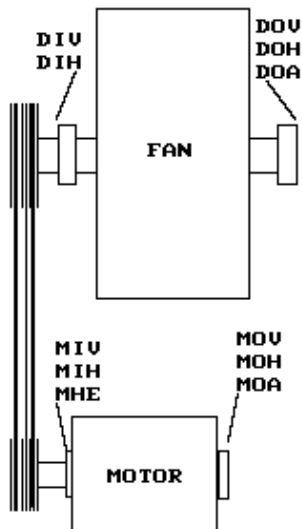
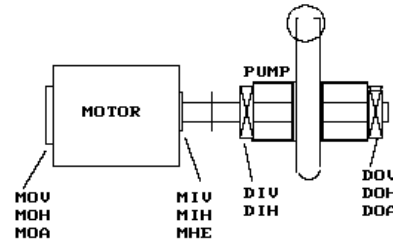
Vibration analysis was conducted on rotating equipment. A brief discussion of each machine exhibiting high vibration levels, along with suggested repairs, is presented on the following pages. Illustrative spectral data for each problem are included. Measurement points are as follow and are illustrated below:

MOV--Motor outboard vertical
MOH--Motor outboard horizontal
MOA--Motor outboard axial
MIV--Motor inboard vertical
MIH--Motor inboard horizontal
MEH--Motor high resolution for electrical faults or high frequency resolution

DIV--Driven machine inboard vertical
DIH--Driven machine inboard horizontal
DOV--Driven machine outboard vertical
DOH--Driven machine outboard horizontal
DOA--Driven machine outboard axial
